2008 Annual Inspection Report

BRADY CANAL HYDROLOGIC RESTORATION PROJECT (TE-28)

State Project Number TE-28
Priority Project List 3

May 1, 2008
Terrebonne Parish

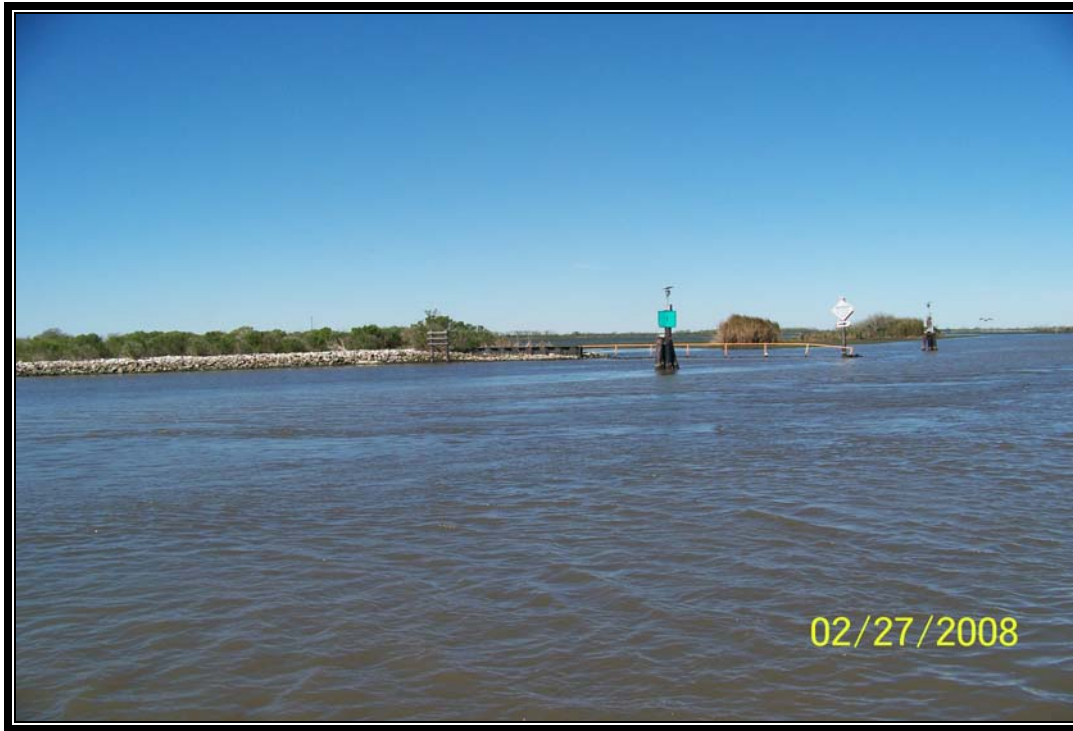
Structure 6 appeared to be in fair condition with severe to moderate damage to the timber pile bumper guard and the steel guard rail attached to the sheetpile wall on the west side of the barge bay entrance and the timber navigational aid pile supports on the south side (Bayou Decade). The batter piles on the two (2) timber navigation aid supports on the south side of the structure were off center and split down the middle. The steel cable wraps tying the timber pile cluster together were very loose. The timber bumper guard on the west side of the barge bay entrance was completely sheared and the guard rail bent. Apparently, barge equipment operated by the oil field service contractor managing the adjacent gas field is damaging the

timber pile cluster and bumper piles while accessing the barge bay. Tim Allen with Apache Minerals has agreed to discuss the damage with the oil field service contractor and request that the contractor facilitate repairs. Minor erosion was also noted on the west side of the structure where the sheetpile wall ties into the earthen embankment. It doesn't appear that breaching of the embankment is imminent; however, it is recommended that the earthen spoil bank in this area be refurbished on the next maintenance cycle. All navigation lights and signage appear to be in good condition. Automatic Power, Inc. of Larose has been maintaining the navigation lights under a maintenance contract with OCPR issued in February 2007. (Appendix B, Photos 1 through 5).

Photo No. 1 – southern end of the fixed crest weir and barge bay (Structure 6) located along the north bank of Bayou Decade. The timber pile supported navigational aid is also shown in this photo.

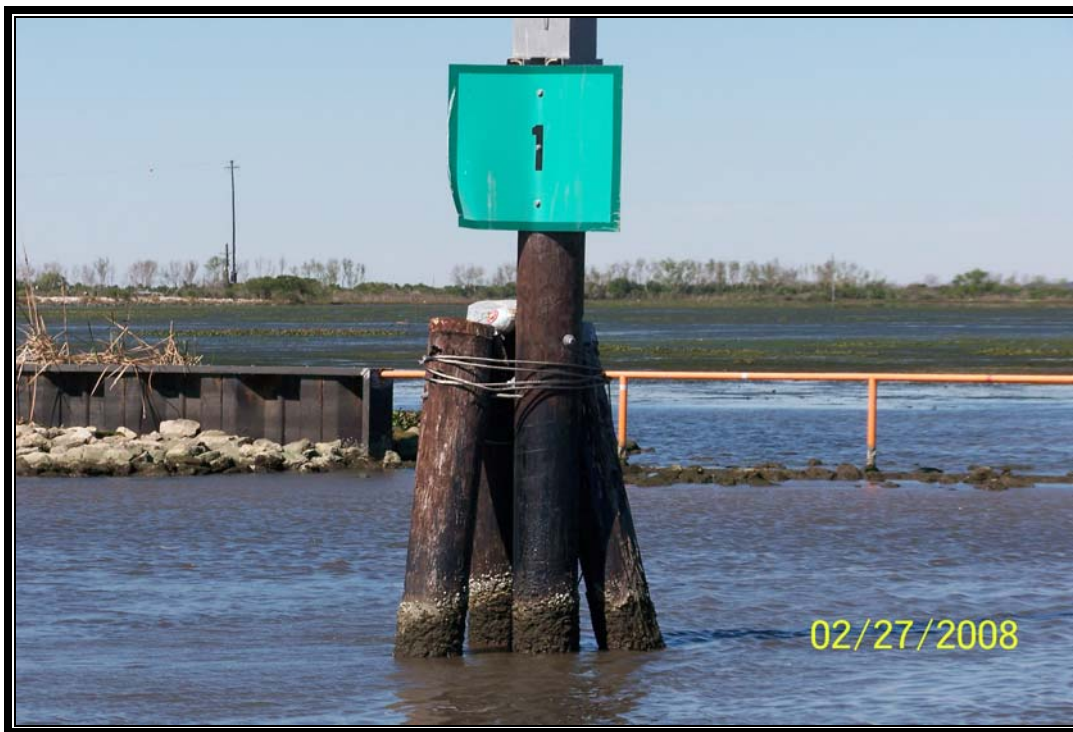
Photo No. 2 – view of damaged timber pile supports for navigational aid structure on the southwest side of Structure 6. The alignment of the three (3) batter piles has shifted exposing the center vertical support.

provided a timely response to project deficiencies as well as a substantial cost savings. With the cooperation of both landowners, it is recommended that earthen embankment and overflow bank maintenance continue to be handled through the in-kind service agreement established in the cost share agreement. In the case of the structure damage to the timber bumper guard and timber navigational aid supports, we recommend that the timber bumper guard on the west side of the barge bay entrance be replaced. Since we are fairly certain that the damage was caused by equipment belonging to the oilfield service contractor, Mr. Tim Allen with Apache Minerals has agreed to discuss the damage with the contractor and request that they facilitate repairs to the timber bumper guard. If this approach is unsuccessful, we recommend that the repairs be included in the next maintenance cycle for the Brady Canal project. At this time, we do not recommend replacing the timber cluster piles supporting the navigation aid system on the south side of Structure 6 since structural failure is not imminent. However, on the next maintenance cycle, we are recommending that the stainless steel cables tying the timber cluster pile together be tightened and secured.

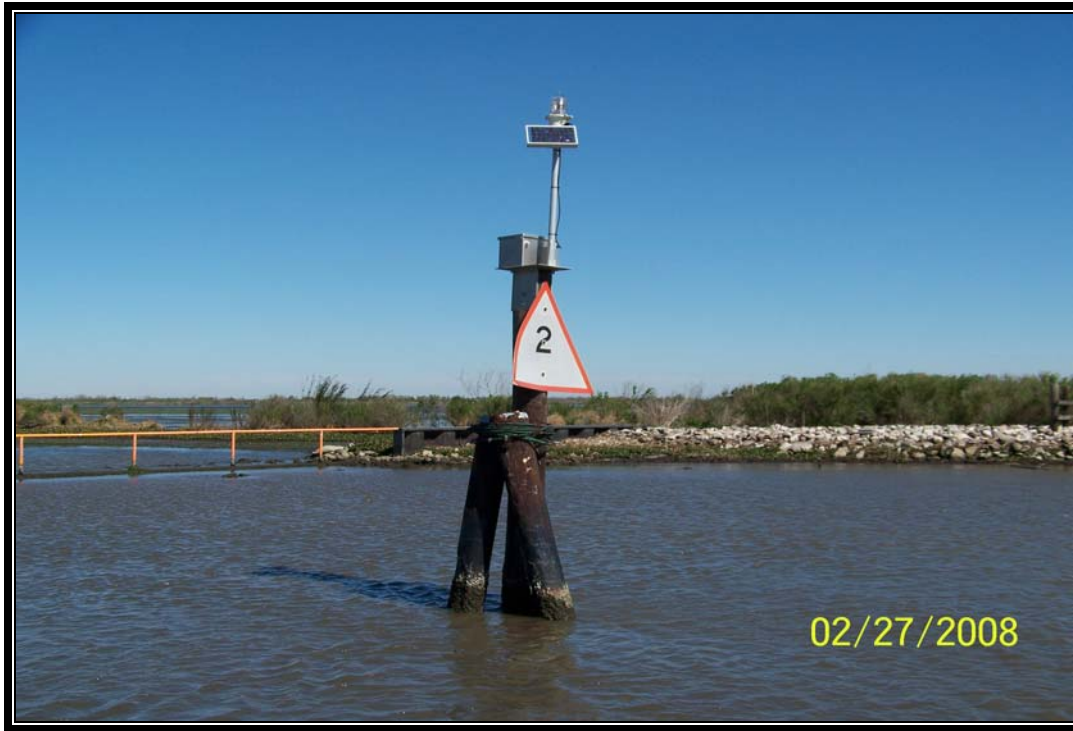
Photo No.3 – view of timber pile support and navigational aid structure on the southeast side of Structure 6. The alignment of the batter piles has also shifted exposing the vertical support pile.

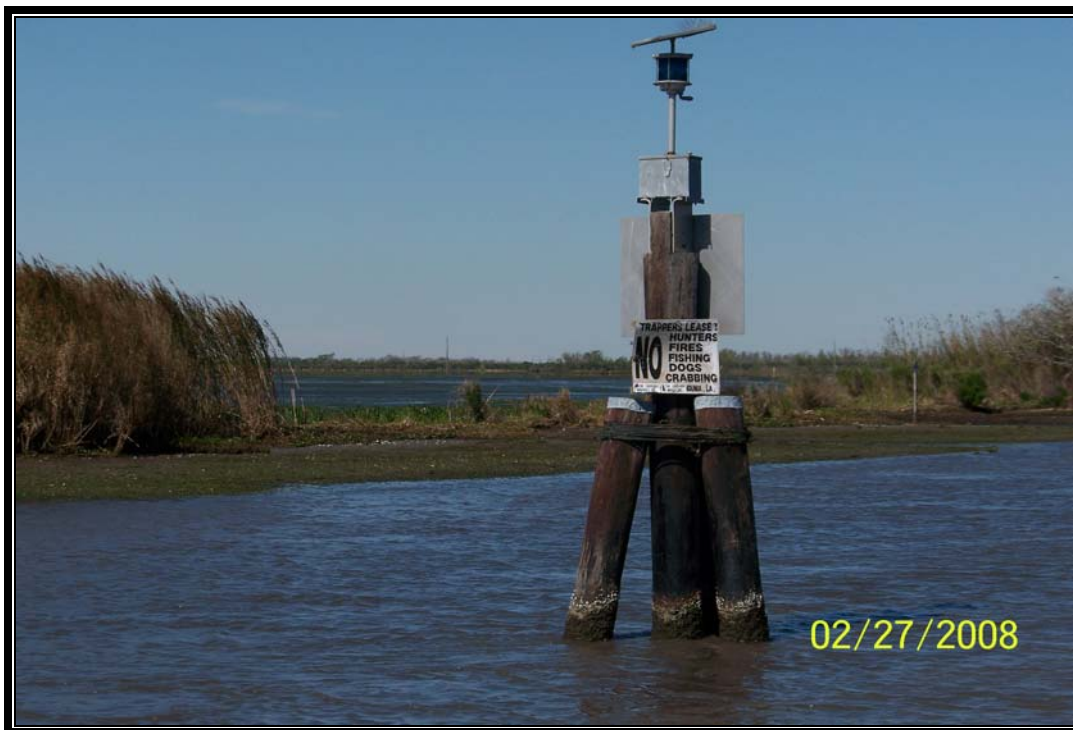
Photo No.4 – view of timber pile support and navigational aid structure on the northwest side of Structure 6.

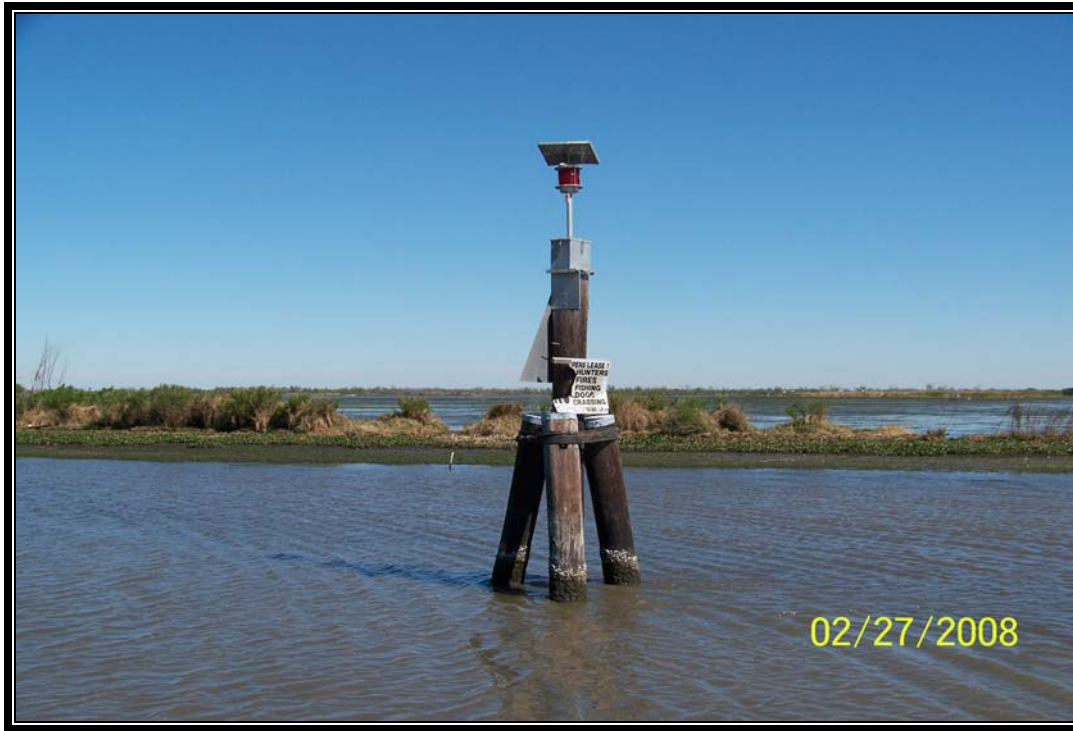
Photo No.5 – view of timber pile support and navigational aid structure on the northeast side of Structure 6.

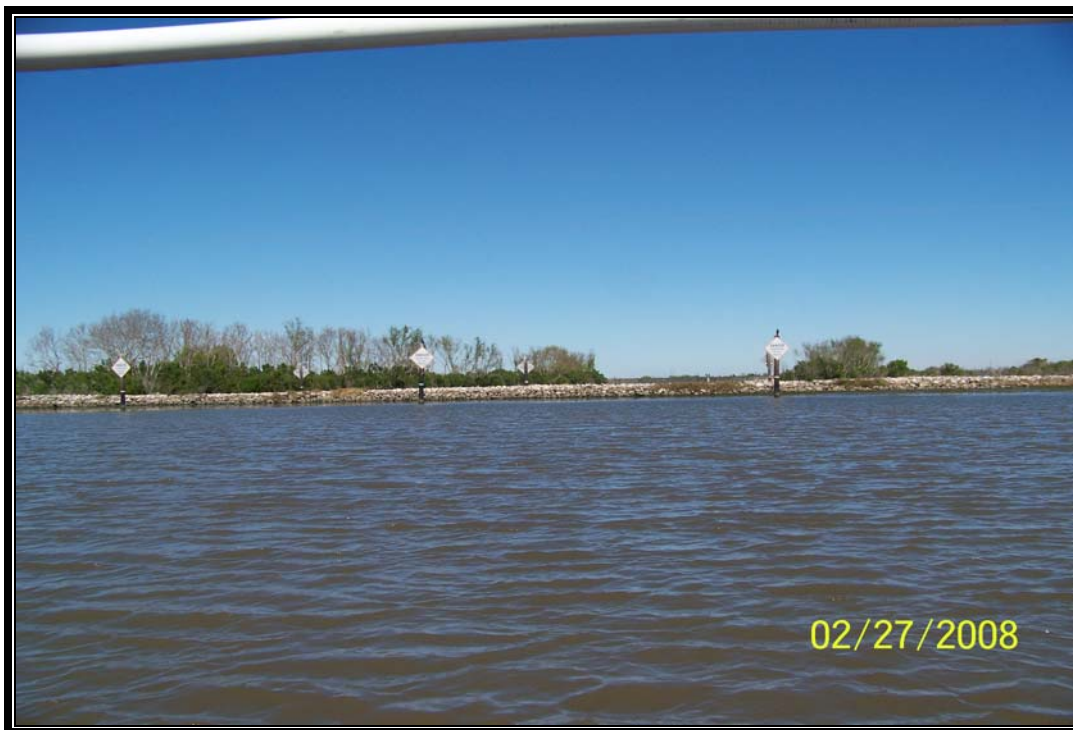
Structure 7 appeared to be in very good condition. There was no indication of settlement along the length of the rock plug. The inspection team agrees that this structure is in good condition and no maintenance will be required at this time. (Appendix B, Photo 6)

Photo No.6 – view of the rock rip rap plug (Structure 7) located along the north bank of Bayou Decade west of Structure 6.

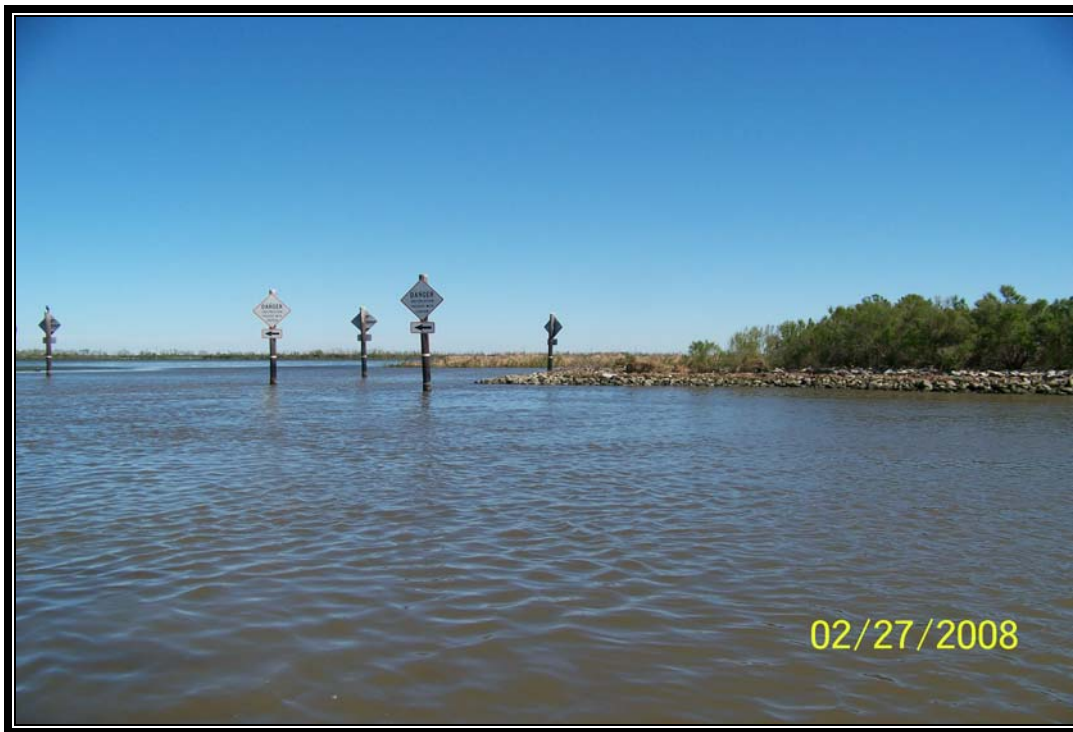
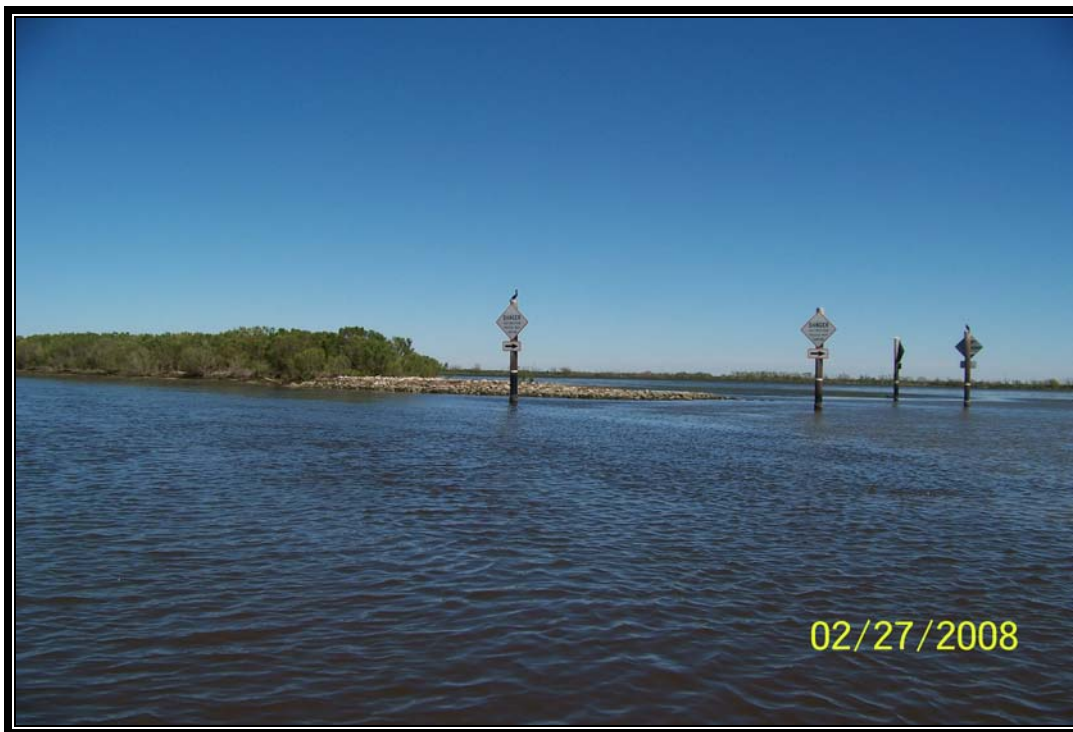
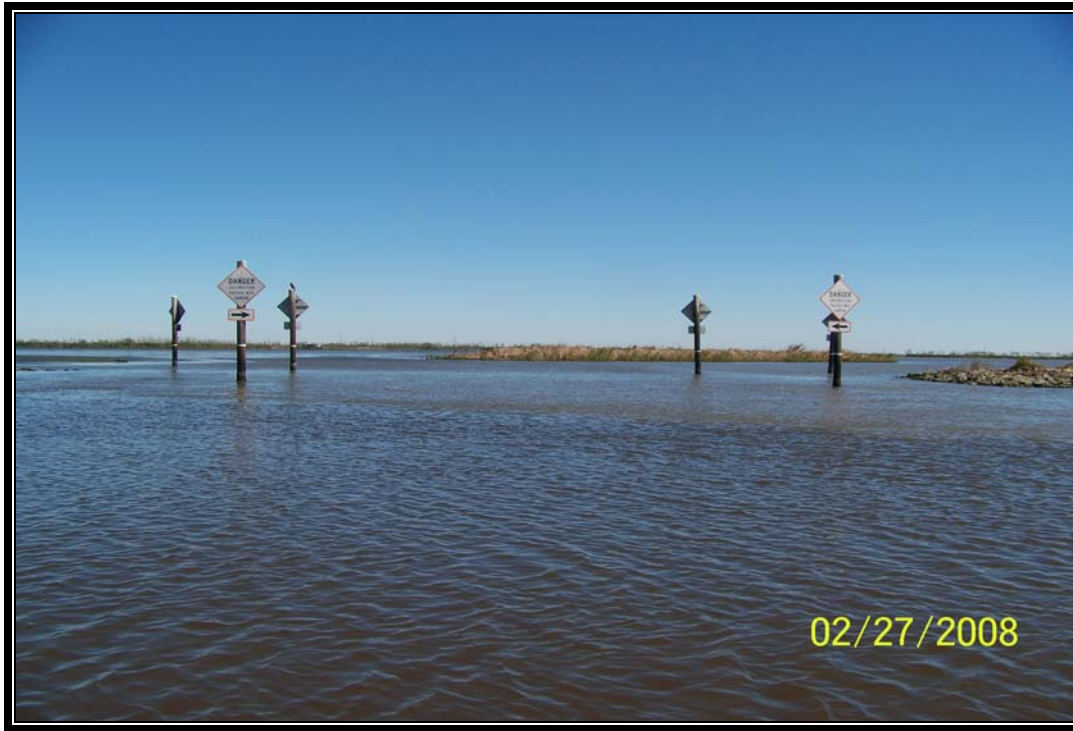
The rip-rap lined channel along Voss Canal appeared to be in good condition with no indication of structure settlement. The warning signs and supports were also in good condition. (Appendix B, Photos 7 through 9).

Photo No.7 – south bank of rock channel liner (Structure 10) located along the east bank of Voss Canal.

Photo No.8 – north bank of rock channel liner (Structure 10) located along the east bank of Voss Canal.

Photo No. 9 – timber sign supports and rock channel liner of Structure 10 looking northeast.

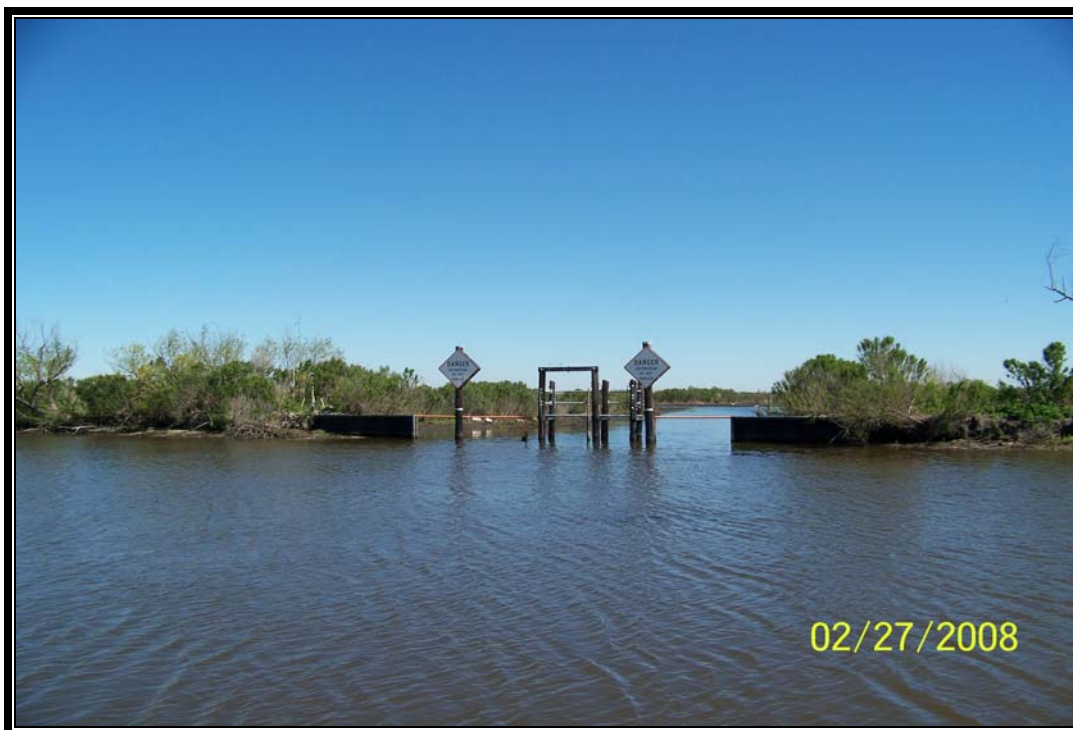
The variable crest weir structure located along the east bank of Bayou Carencro appeared to be in very good condition with only minor erosion noted on each side near the earthen embankment tie-ins. The signs, timber supports and structural components of Structure 14 were in good condition with no indication of damage or serious corrosion. All signs and supports were also in good condition (Appendix B, Photo 10).

Photo No.10 – variable crest weir structure (Structure 14) located along the east bank of Little Carencro Bayou.

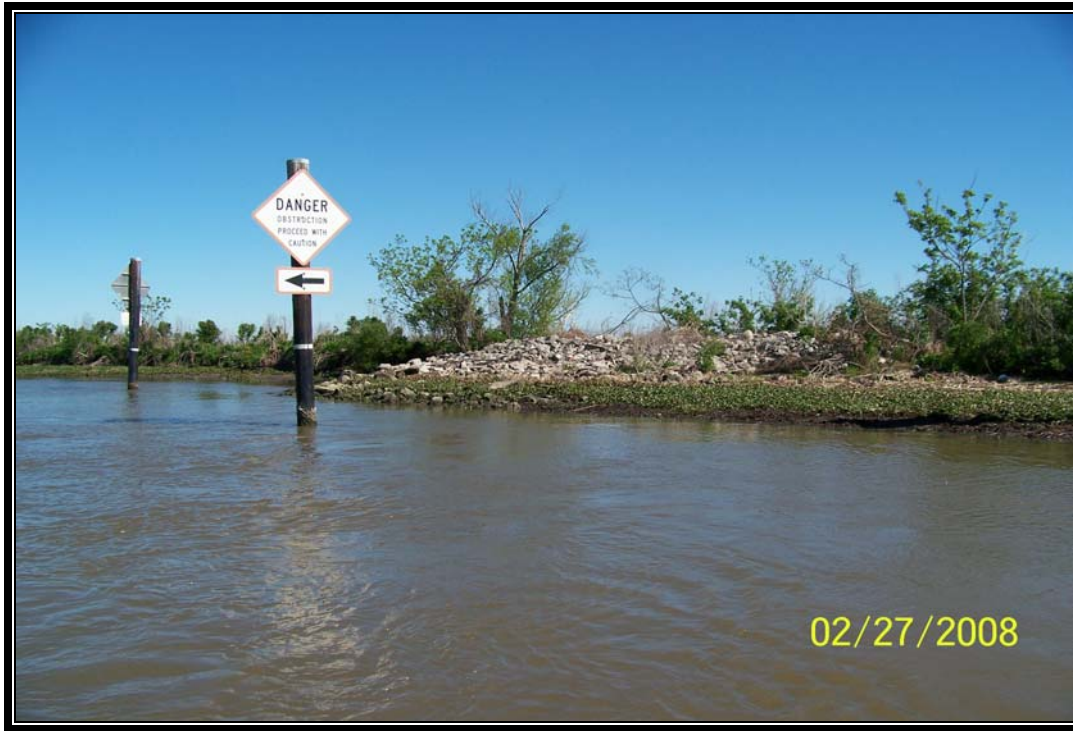
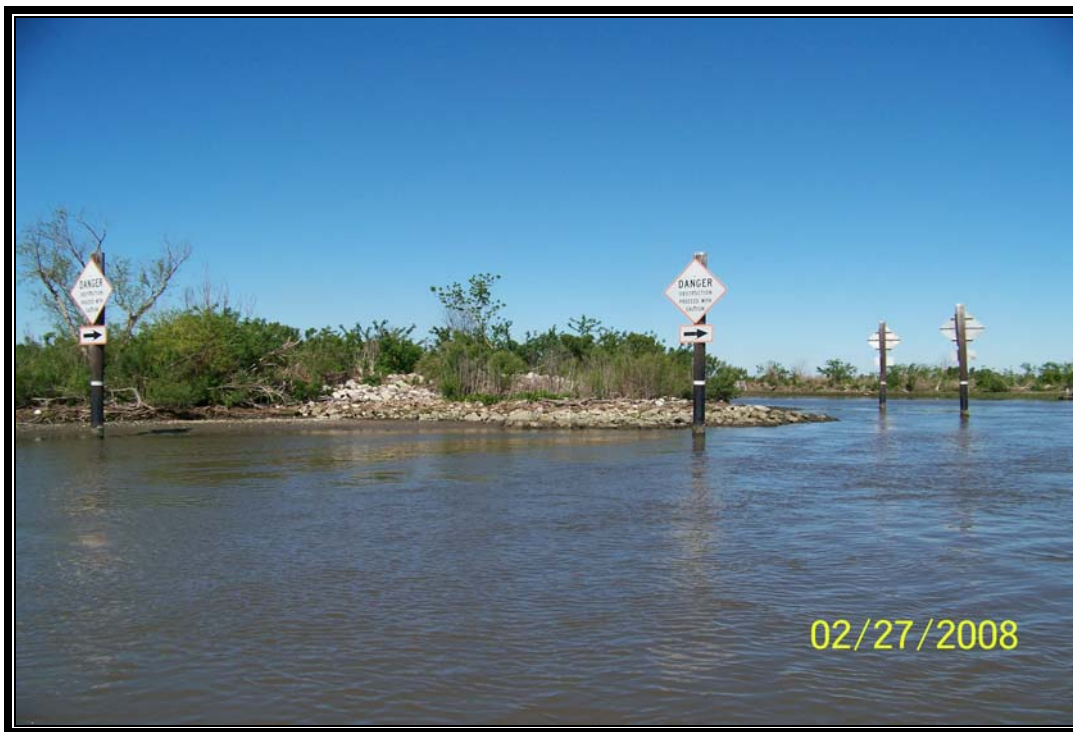
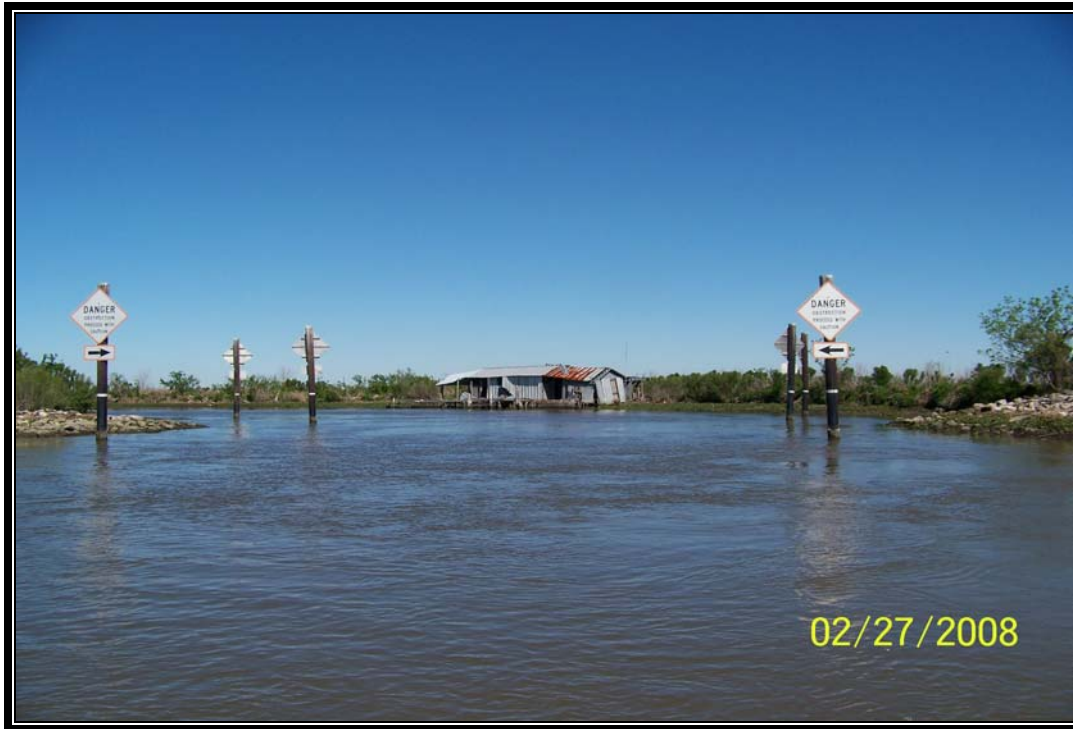
Rock rip-rap channel liner located along the west bank of Jug Lake appeared to be in very good condition with no visual signs of settlement. The warning signs and timber pile supports were also in very good condition. The depth of water above the rock riprap at the center of the channel was approximately 6.1 to 6.5 feet. . With estimated water levels in Jug Lake of -0.25 NAVD at the time of the inspection, we have concluded that the crest of the rock riprap structure near the center of the channel was approximately -6.5' NAVD. The crest of the structure in this area was originally constructed to -4.75 NAVD, indicating that the structure has settled approximately 1.75' in the center of the channel. Prior to recommending maintenance or corrective actions, a survey profile of the structure should be conducted to confirm field measurements. (Appendix B, Photos 11 through 13)

Photo No.11 – northern end of rock channel liner (Structure 20) located along the southwest bank of Jug Lake.

Photo No.12 – southern end of rock channel liner (Structure 20) located along the southwest bank of Jug Lake.

Photo No.13 – view of rock channel liner, timber piles and signage of Structure 20.

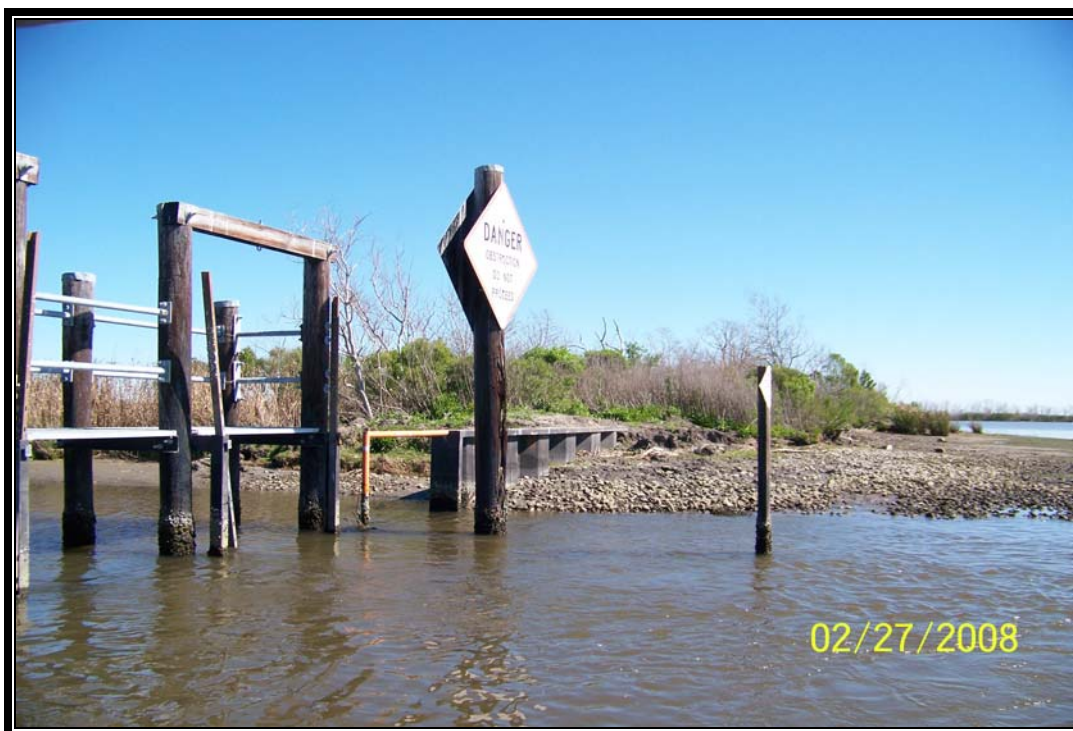
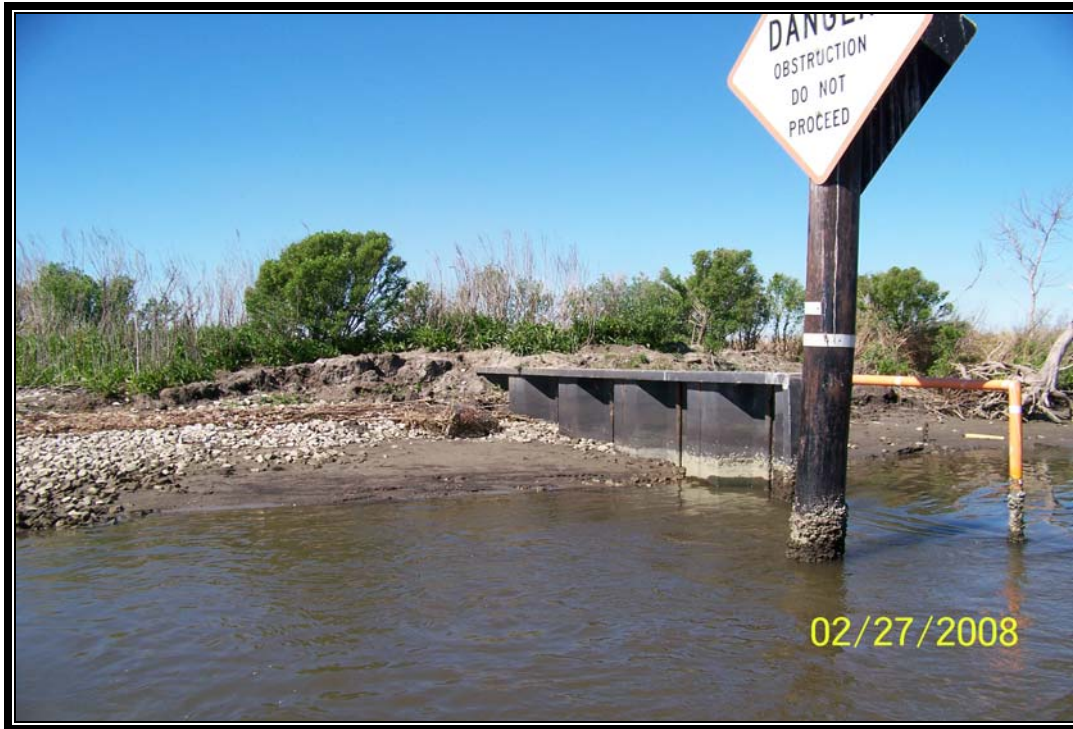
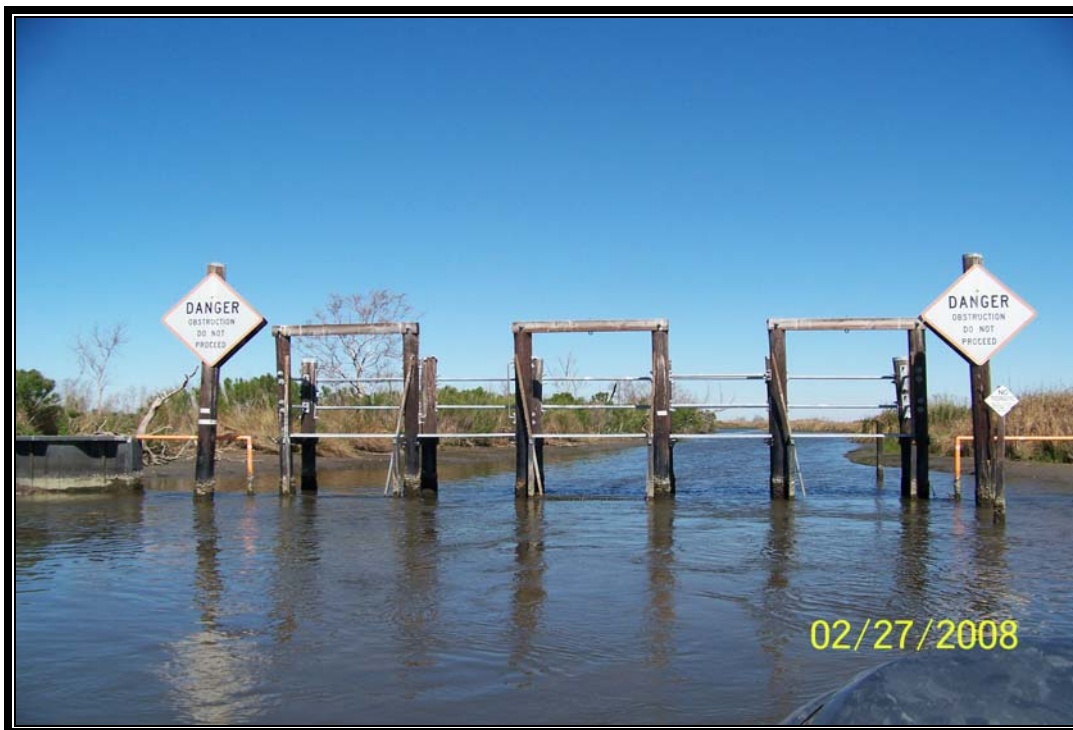
The variable crest weir structure with three (3) stop log bays appeared to be in good condition with no visual damage, breaching or corrosion of the structural components. The earthen embankment tie-ins on both sides of the structure exhibited minor erosion with large cut banks on the south side. The channel guides used to lock the stop logs into position were not secured during the last operations event causing several of the top logs to float to the surface. A single stop log was recovered along the shoreline adjacent to the structure confirming that one or more stop logs may have floated out of the channel guides. Prior to the upcoming structure operations event in March 2008, an inventory of stop logs shall be taken to determine if any additional logs were lost. OCPH shall instruct the contractor performing operations that channel locks must be secured on all structures prior to demobilizing from the site. The earthen embankments adjacent to the structure were refurbished by Apache Minerals in July 2007 under their in-kind service contract with OCPH and are in good condition. (Appendix B, Photos 14 through 16)

Photo No. 14 – sheet pile wall tie-in to earthen embankment, timber pile support and signage on the north side of variable crest weir (Structure 21) located on the northwest bank of Jug Lake.

Photo No. 15 – sheet pile wall tie-in to the earthen embankment, timber support and signage on the south side of variable crest weir (Structure 21) located on the northwest bank of Jug Lake.

Photo No.16 – view of three (3) bay variable crest weir (Structure 21) located on the northwest bank of Jug Lake.

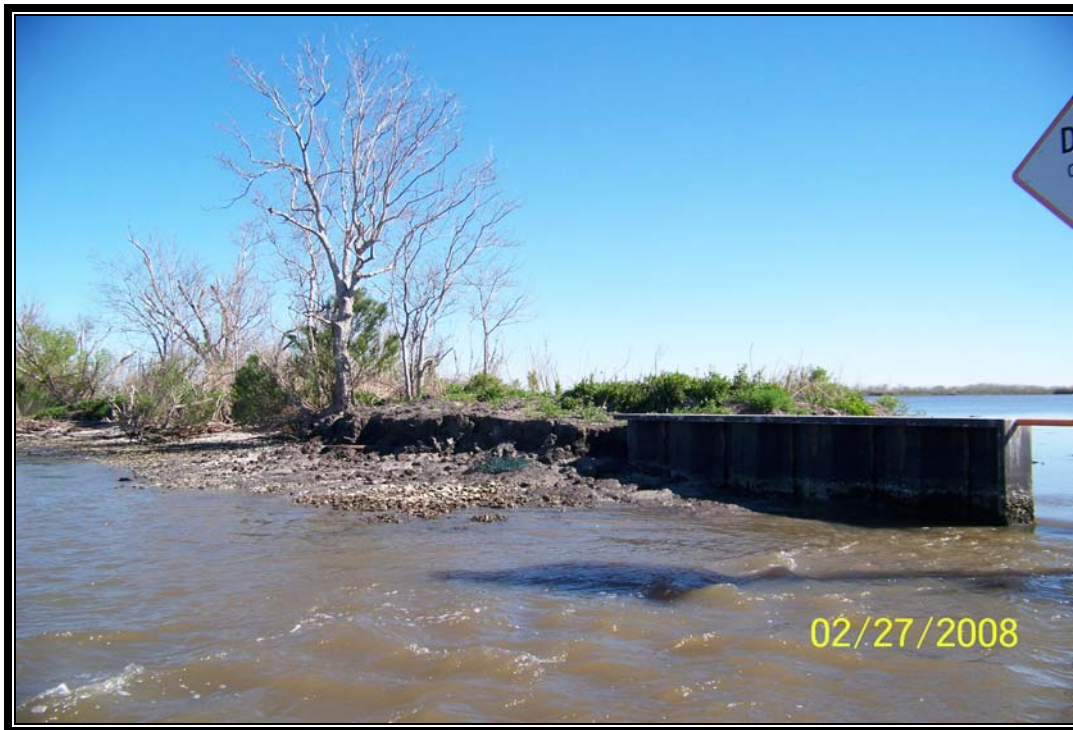
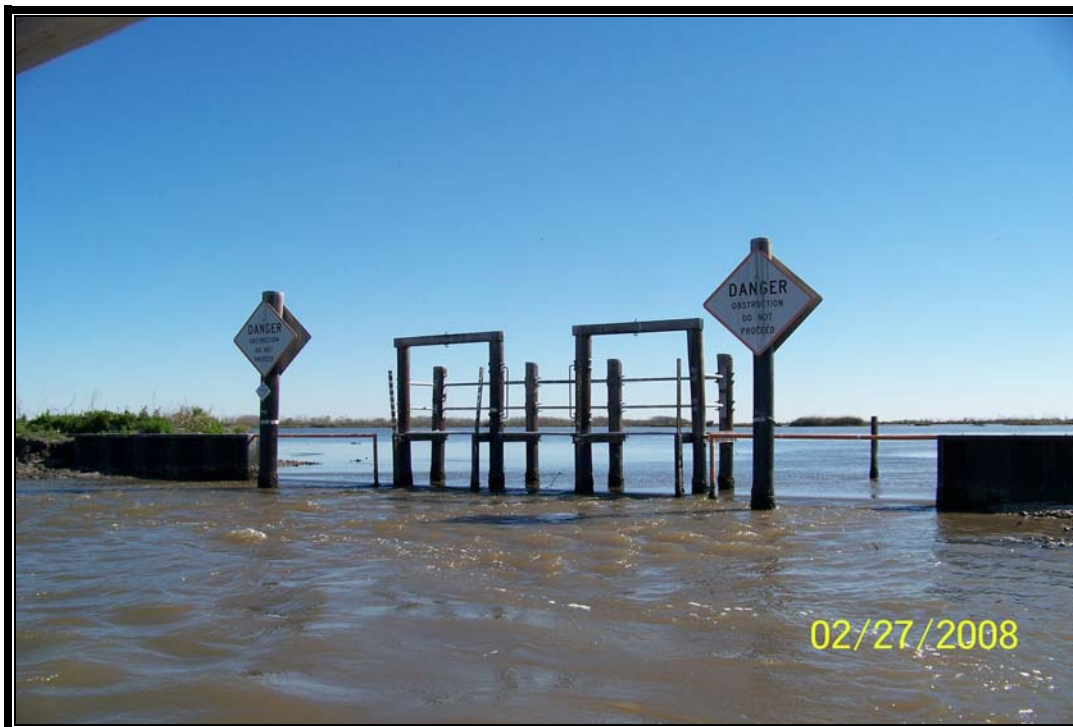
The variable crest weir structure appeared to be in fair condition with no noticeable damage or corrosion of the structural components. We did observe moderate erosion on both sides of the structure near the earthen embankment tie-ins. Although the earthen embankment was refurbished in July 2007, large cut banks have reappeared on both sides of the structure. All signs and timber supports were in good condition. (Appendix B, Photos 17 and 18)

Photo No.17 – tie-in to earthen embankment on the north side of the variable crest weir (Structure 23) located on the northeast bank of Jug Lake.

Photo No.18 – view of two (2) bay variable crest weir (Structure 23) located along the northeast bank of Jug Lake.

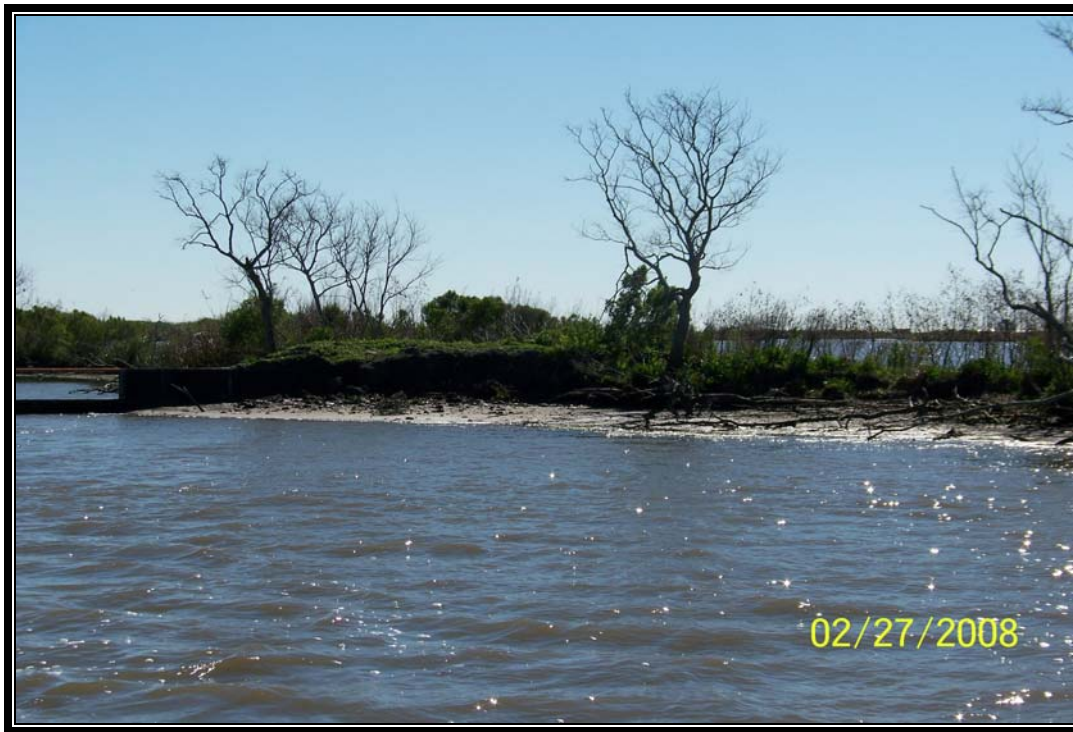
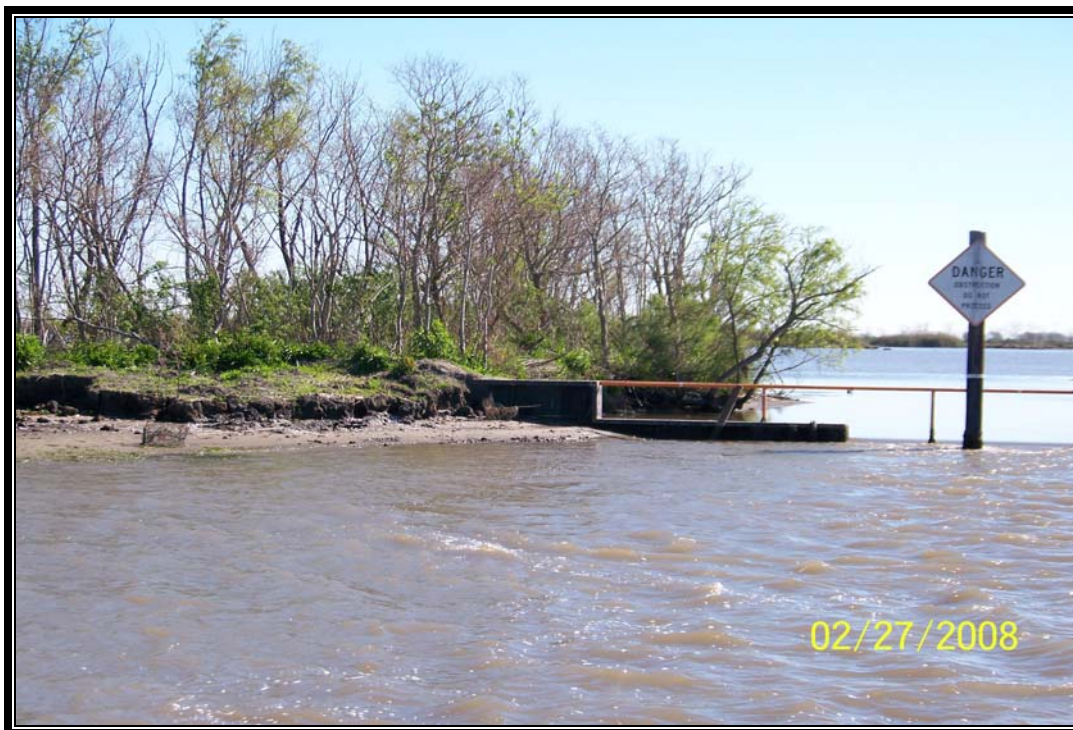
The fixed crest weir located along the southeast bank of Jug Lake appeared to be in very good condition with no visual signs of corrosion or erosion of the earthen tie-ins. The earthen tie-ins were refurbished by Apache Minerals, Inc. in July 2007 and are holding up well. All signs and timber supports were also in good condition. (Appendix B, Photos 19 and 20)

Photo No. 19 – view of the earthen embankment tie-in on the south side of the fixed crest weir (Structure 24) on the southeast bank of Jug Lake.

Photo No. 20 – view of the earthen embankment tie-in on the north side of fixed crest weir (Structure 24) along the southeast bank of Jug Lake.

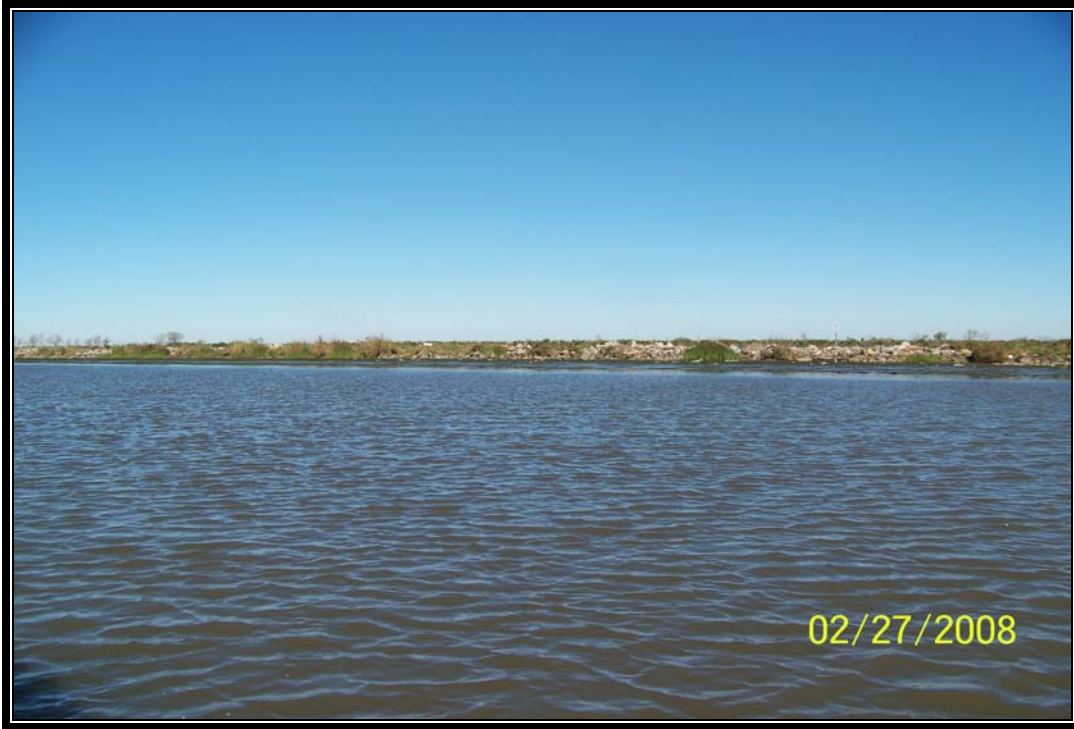
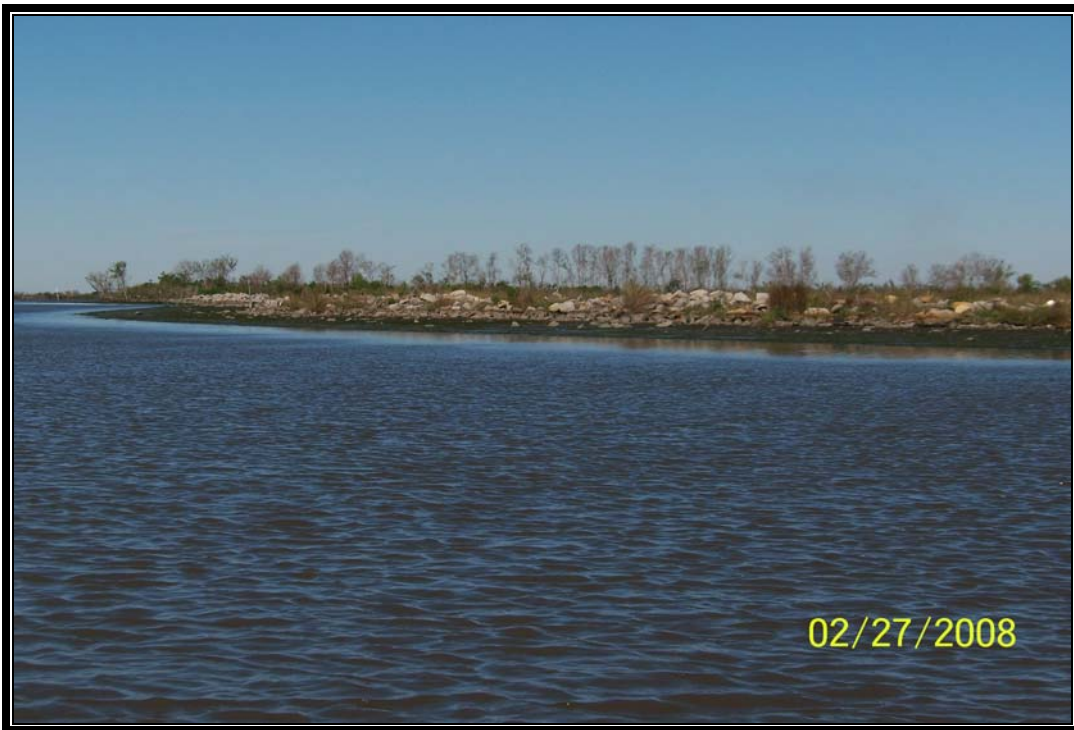
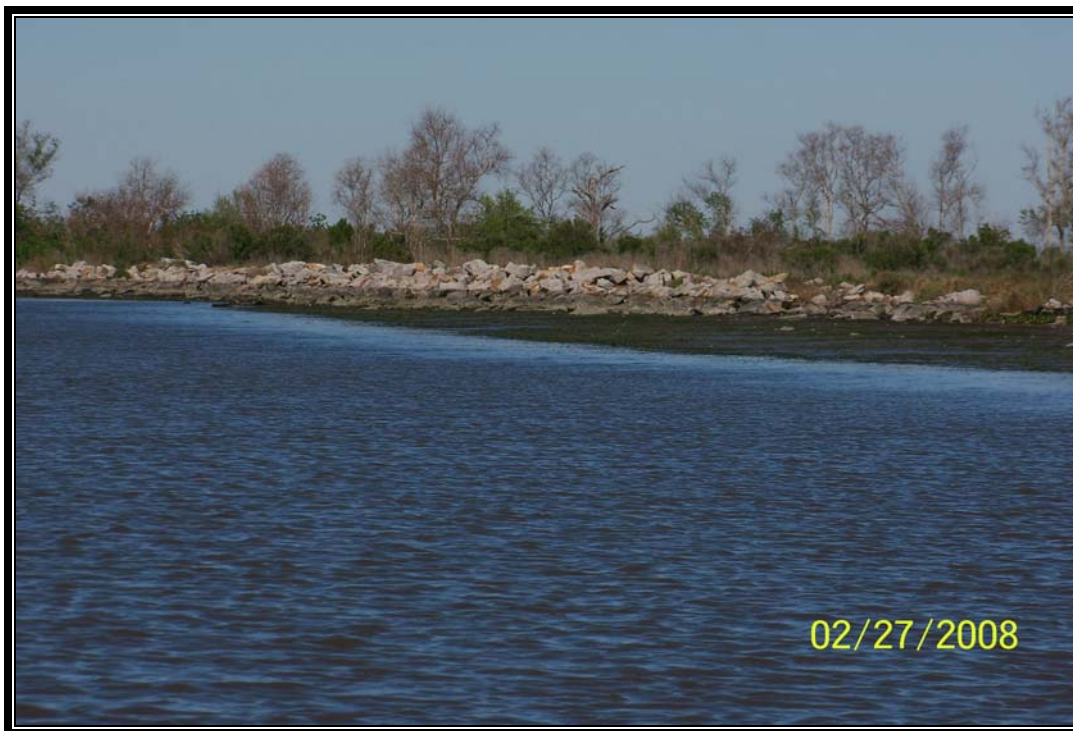
Breach Repair 1 thru 4 - Breach 1 thru 4 consisted of the construction of a rock dike and breach closures along a low lying ridge on the south bank of Bayou Decade from Turtle Bayou to the mouth of Jug Lake. After reviewing photographs of the structure

before and after Hurricanes Katrina and Rita, it is apparent that tidal surges during the storm had resulted in moderate displacement of the rock riprap. Considering the rock displacement that has taken place, the dike remains in good to fair condition with only isolated locations where settlement was visible. (Appendix B, Photos 21 - 25)

Photo No. 21 – rock dike revetment (Breach Repair 1 through 4) along north bank of Bayou Decade between Turtle Bayou and Jug Lake installed in 2003.

Photo No. 22 – rock dike revetment (Breach Repair 1 through 4) along northern bank line of Bayou Decade between Turtle Bayou and Jug Lake installed in 2003.

Photo No. 25 –rock dike revetment along Bayou Decade near entrance to Jug Lake installed in 2003.

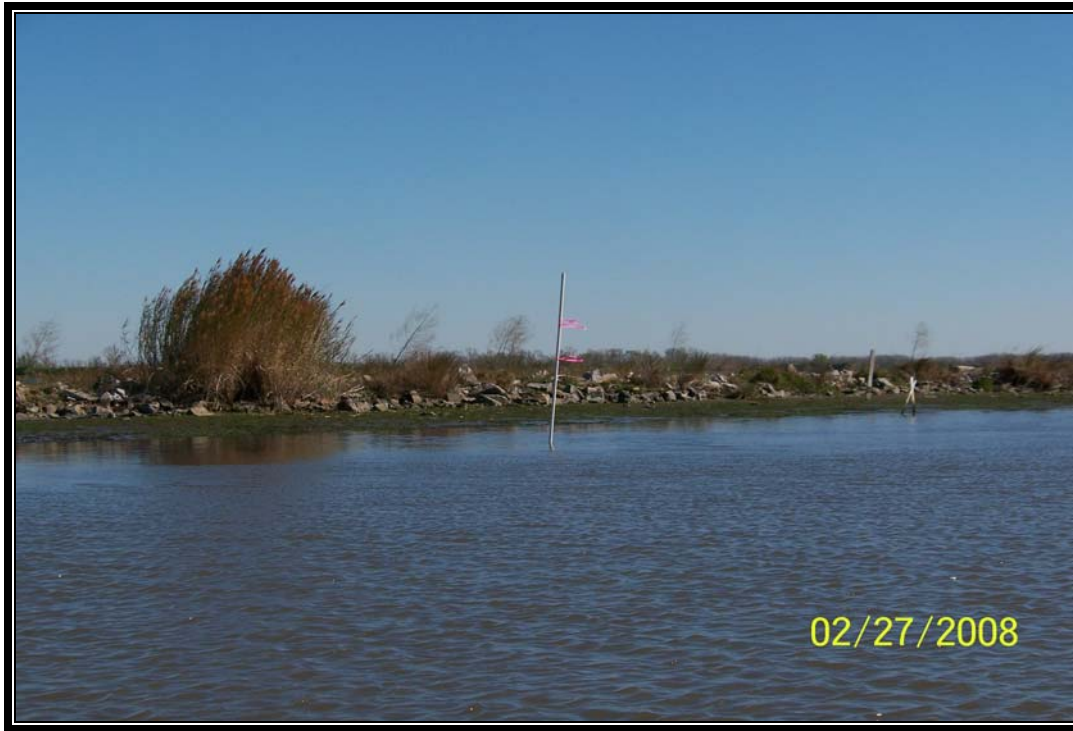
OCPR has received four (4) complaints from boaters in the area regarding boat motor damage as a result of an underwater obstruction below the water surface along the north bank of Bayou Decade between Turtle Bayou and Jug Lake. Each complaint indicated that as they were traveling Bayou Decade they struck an underwater obstruction, presumably large rocks below the water surface, causing damage to their outboard motors. At least one (1) of the boaters was able to provide an approximate location of the underwater obstruction. OCPR field personnel visited the site to investigate and found a small 2 feet diameter patch of rocks (2 or 3 large stones) below the water surface in the vicinity of the reported incident. This location was approximately 20 to 25 feet from the bank in 1 foot of water at the time of the investigation. A 50 linear feet section of Bayou Decade was marked with PVC pipes and ribbon to notify boaters of possible underwater obstruction. Each individual was asked to provide OCPR a written statement including dates, type of boat, travel speed, size of motor, description of damage and any other information and photos that would assist in assessing the damages. To date, only one individual has submitted the information requested by OCPR. This claim was reported to the risk management section of OCPR for further investigation. OCPR will continue to monitor this area until corrective action can be taken.

Photo No. 23 – rock dike revetment along Bayou Decade between Turtle Bayou and Jug Lake installed in 2003. PVC pipe with flagging serves as a marker for underwater obstruction (rocks) reported in early 2008.
